CONDUCTOR STABILISATION ASSEMBLY EXTENDS THE LIFE OF CORRODED MIDDLE EAST WELL

Claxton provided an innovative clamp and sleeve assembly to preserve a severely corroded conductor which was buckled just above the splash zone.

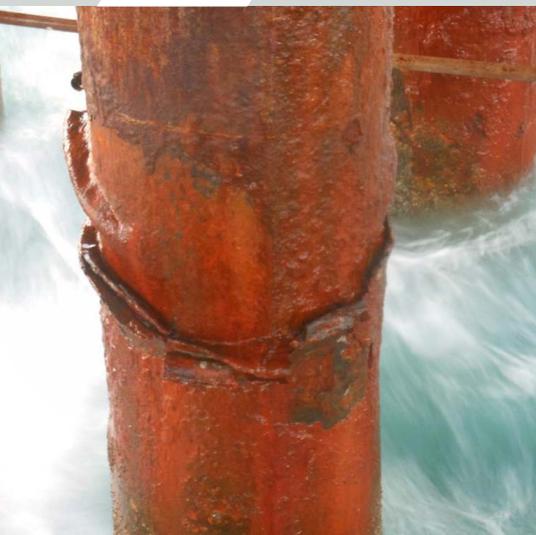
A well report confirmed that due to internal well tension and severe corrosion, the well conductor had buckled just above the splash zone area.

Metal was found flaking away from the conductor, resulting in a distorted area of 750mm. Conductor clamps were not available to the client which is why they called on Claxton to devise a rapid solution to save the well.

Claxton's technicians installed beam clamps to allow them to lift the components into position. The clamp was then successfully fitted below the main sea level (MSL) and torque equipment was applied subsea to tighten the clamp on to the conductor. The conductor sleeve was then welded, painted and installed at the splash deck and bolt torque equipment was applied to the sleeve and subsequently, the torque sleeve to the clamp.
