CONDUCTOR STABILISATION ASSEMBLY EXTENDS THE LIFE OF CORRODED MIDDLE EAST WELL

Claxton provided an innovative clamp and sleeve assembly to preserve a severely corroded conductor which was buckled just above the splash zone.

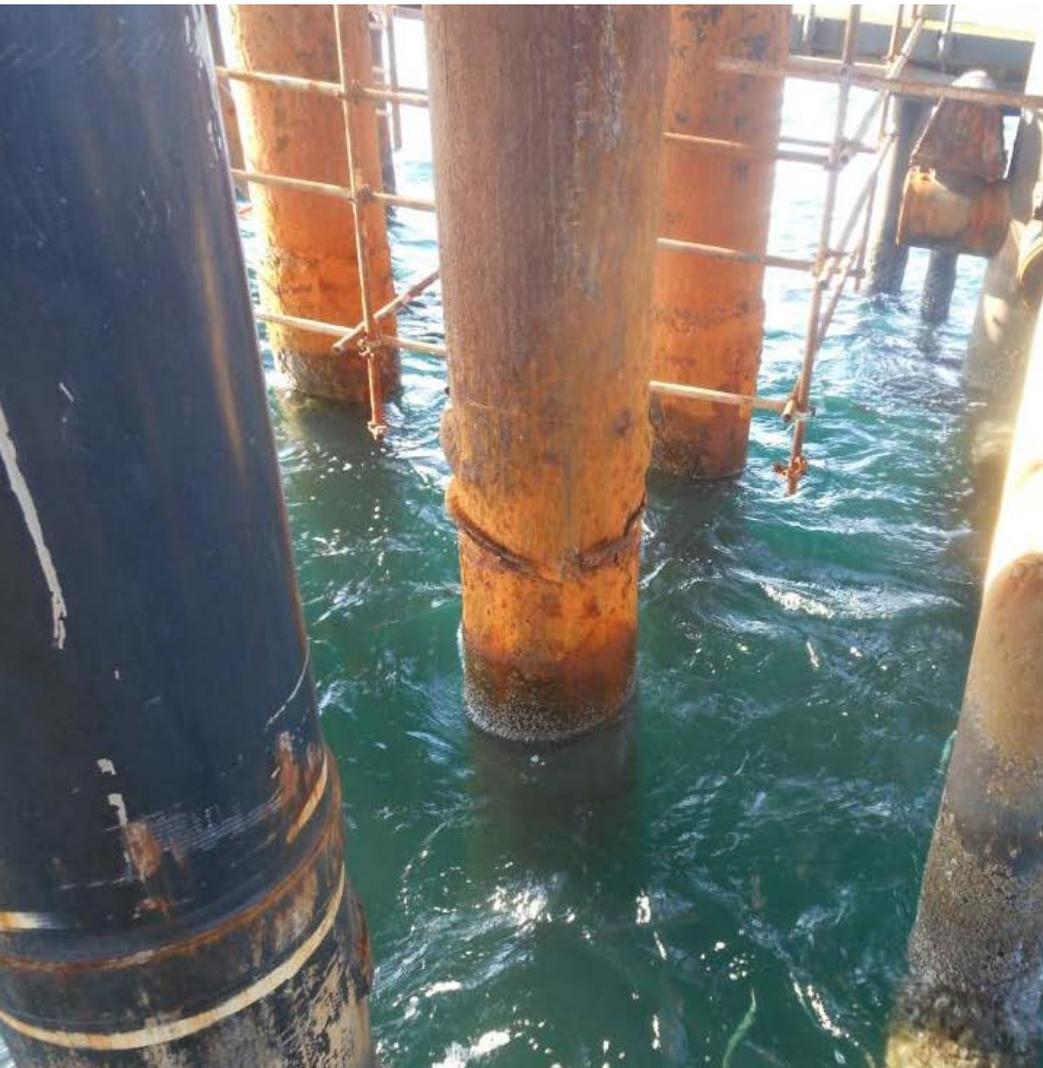
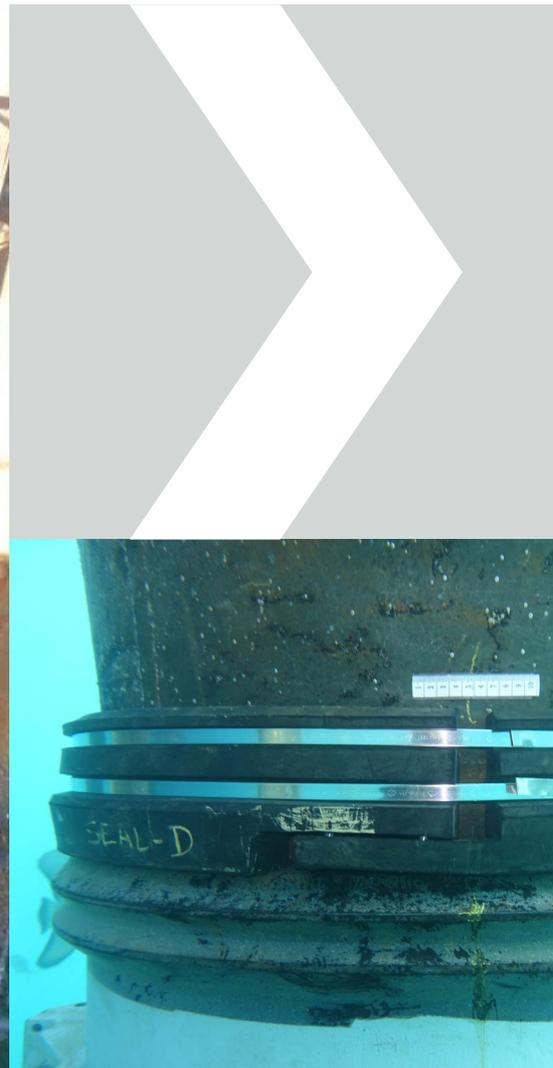
A well report confirmed that due to internal well tension and severe corrosion, the well conductor had buckled just above the splash zone area.

Metal was found flaking away from the conductor, resulting in a distorted area of 750mm. Conductor clamps were not available to the client which is why they called on Claxton to devise a rapid solution to save the well.

A Claxton tension ring was fitted to the conductor just below the wellhead system, which allowed it to react off the wellhead deck at the agreed force.

Well repair operations commenced with a third-party dive team performing a subsea survey, along with the removal of any metal protrusions from the buckled area, whilst also blast cleaning the conductor.

The assembly provided and installed by Claxton has preserved the degraded

well conductor and provided protection against continuous degradation from the harsh environmental conditions seen primarily around the splash zone.
